NPDES Permit Number: MAR10D585

Project Name: **Route 62 Roadway Resurfacing and Reconstruction**
Project Address: Route 62 Concord, Massachusetts
Project Proponent: **Town of Concord Public Works/ MHD**
Report Prepared By: Mary Trudeau, Environmental Consultant
Date of Report/Site Visit: October 16, 2009

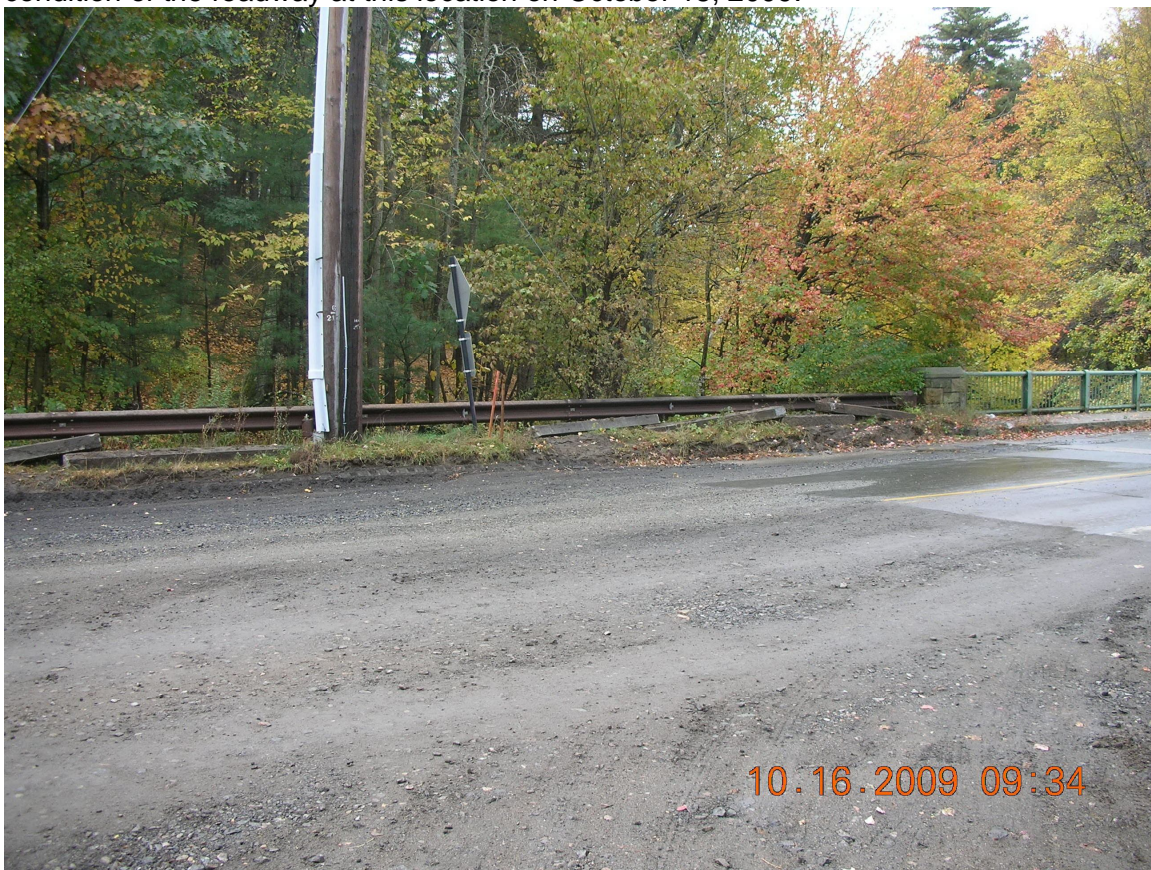
Work in proximity to the Assabet River, at the Acton town line, included grinding, grading and curb removal. The work is largely **below** the elevation of the adjacent shoulders, and there was no impact to the downgradient waterway. The following photo shows the condition of the roadway at this location on October 18, 2009:

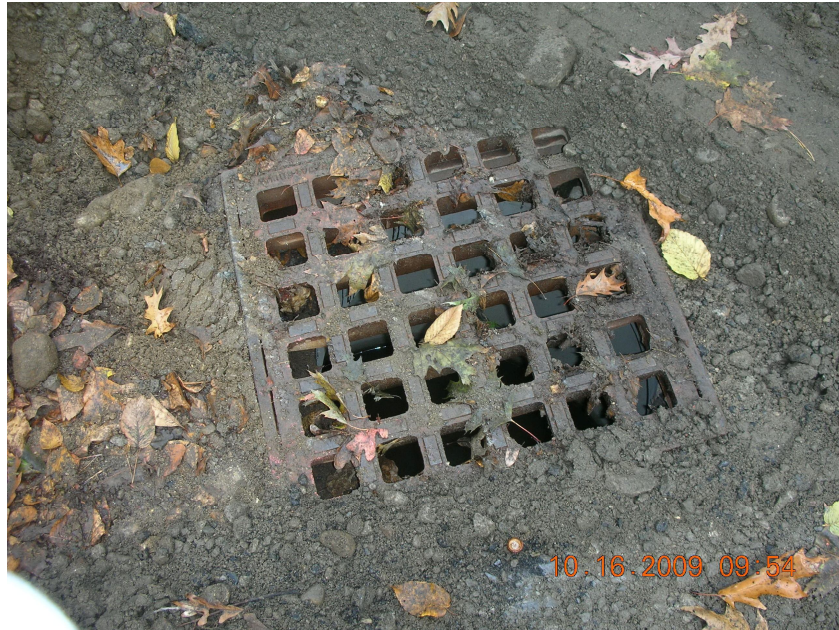
While the majority of the drainage structures within active work areas are protected, I did find a few other catch basins within disturbed watersheds that the fabric liners had slipped or that still required protection. In particular, the catch basin located just west of Cranberry Lane, on the south side of Route 62 is open and needs at least a geotextile fabric liner. The following photo shows the structure :

1. The contractor should replace the catch basin liner in the drainage structure to the west of Cranberry Lane (station point 23+90).

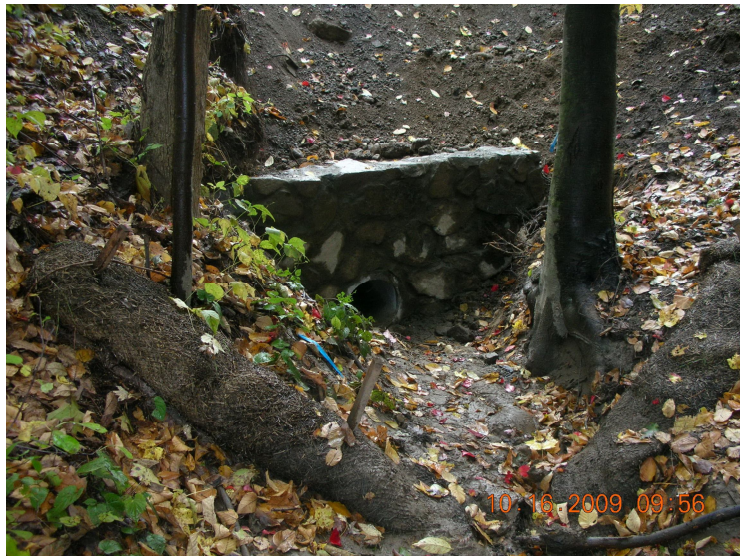
This week the contractor rebuilt the outfall on the north side of Route 62, located at station point 23+25. While the shoulder has been rebuilt and is relatively stable, the work resulted in the deposition of fine silty sediment within the area between the culvert and the down gradient erosion controls. I would recommend hand removal of the sediments, and adding stone to the outfall to stabilize the channel below the culvert. The following photos show this area of concern:

As can be seen in the photo, there is an accumulation of fines on the check dam/wattle immediately below the outfall. While there is silt fence and haybale check dam below, this wattle is now acting to discharge sediment as the flows from the culvert pass over or through the wattle. I would recommend replacing this wattle, or shifting it so that an unsilted section of the wattle lies across the flow path.

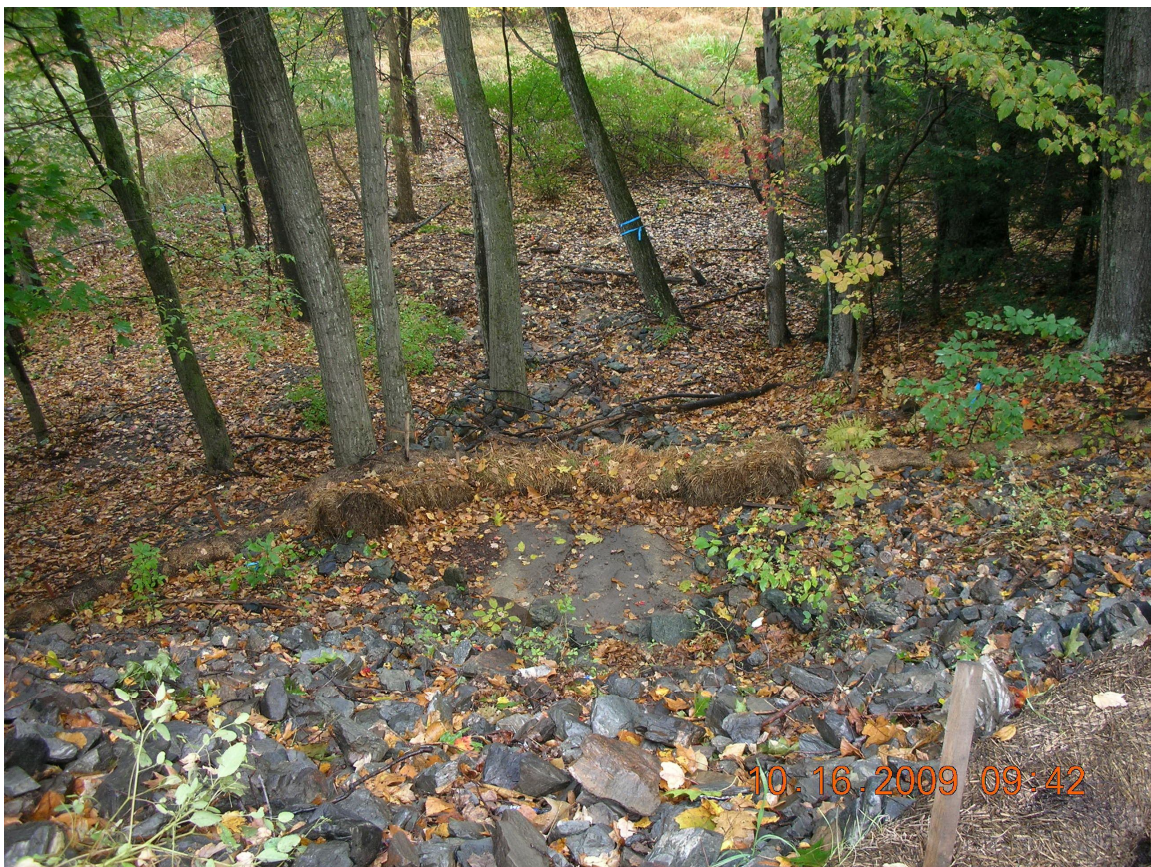
I continue to have some residual concern with the outfall at station point 15+00, on the north side of Route 62. While the erosion controls looked intact, it was apparent that there has been some historic discharge of sediment to downgradient buffer zone and wetland resource areas. While I suspect the discharge happened several weeks ago, the recent die back of the herbaceous plants in the locus has revealed the drainage patterns below the outfall. While the accumulations are not significant, the contractor should send a laborer to rake and remove any deposits of material. The following photo shows this area on October 18, 2009:

3. The contractor should address the sedimentation that has occurred down gradient of the drainage outfall at station point 15+00. Raking and hand work is the appropriate remediation.

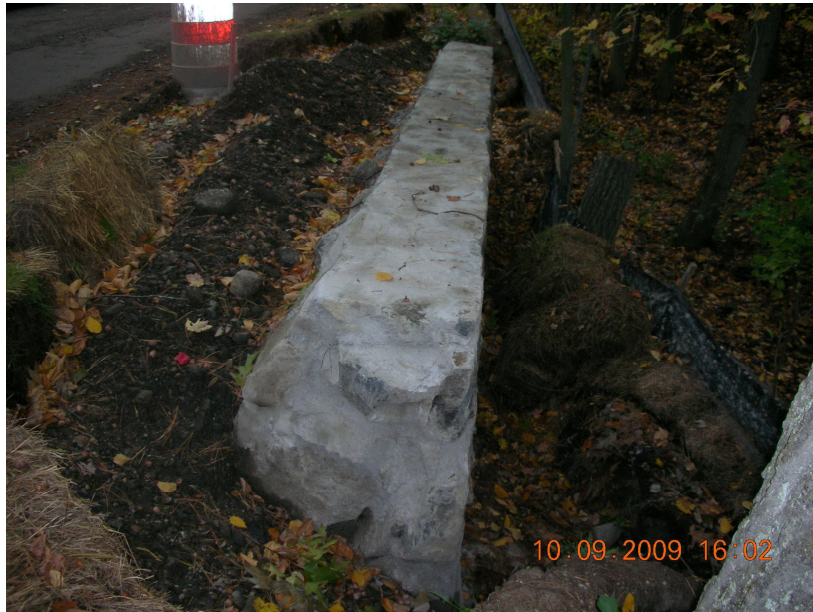
As noted in earlier reports, I am concerned with the upcoming detailing of the slope adjacent to either end of the easternmost retaining wall. This wall is located at approximately station point 27+50, on the south side of Route 62. I spoke with Alan Visco of EH Perkins Construction and noted that I am concerned that the work should include stone and hand work to stabilize the area at either end of the wall. The contractor should insure, particularly on the eastern end of the wall (left hand photo below) that the materials used to stabilize the slope utilize the erosion controls for support. The toe of the finished slope should be set, and stabilized, at the back side of the retaining wall, and should not encroach onto the down gradient silt fence barrier. The

following photo shows the areas of concern, as well as the recently installed hay bales above the new wall (at the southern edge of Rt 62):

5. The contractor should consider the slope treatment of either end of the retaining wall at station point 27+00, on the southern shoulder of Route 62, and should plan on hand work in the more sensitive areas.

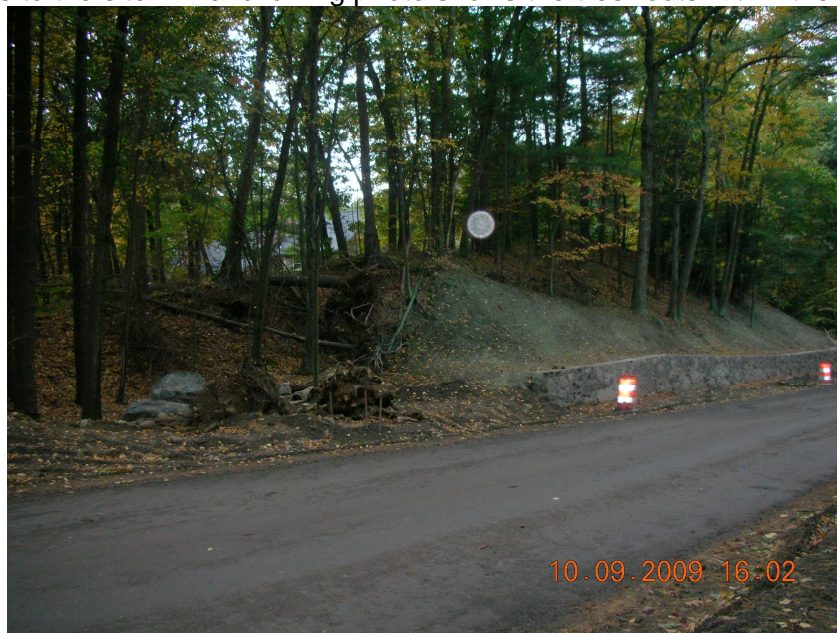
Also noted in earlier reports, Mrs. Sulewski, a condominium owner on Cranberry Lane noted that a tree fall at the south side of Route 62, at approximately station point 25+75 has fallen into and across her yard. Alan Visco and Minot Wood of EHPerkins Construction have determined that the tree fall is within forty feet of the centerline of the road (and is their responsibility) and that it will be cut and removed when the tree cutting crew returns to the site. The following photo shows the tree roots within the job locus:

6. The contractor should remove the tree fall at station point 25+75. It should be cut and removed from the site.
7. There is also a little pile of slash on the south side of the erosion controls at station point 28+25 (south side of Route 62) that should be pulled and disposed of off site. This was left by the tree cutters in the initial clearing of the site.

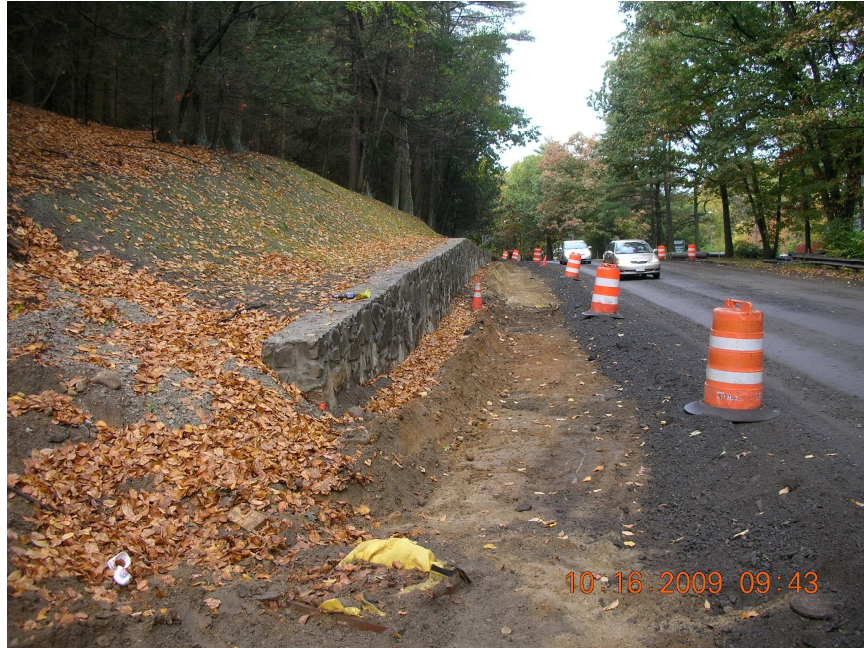
The recent hydroseed applications have begun to germinate, and some of the road shoulders are becoming stabilized. The following photo shows the new grass above one of the retaining walls.

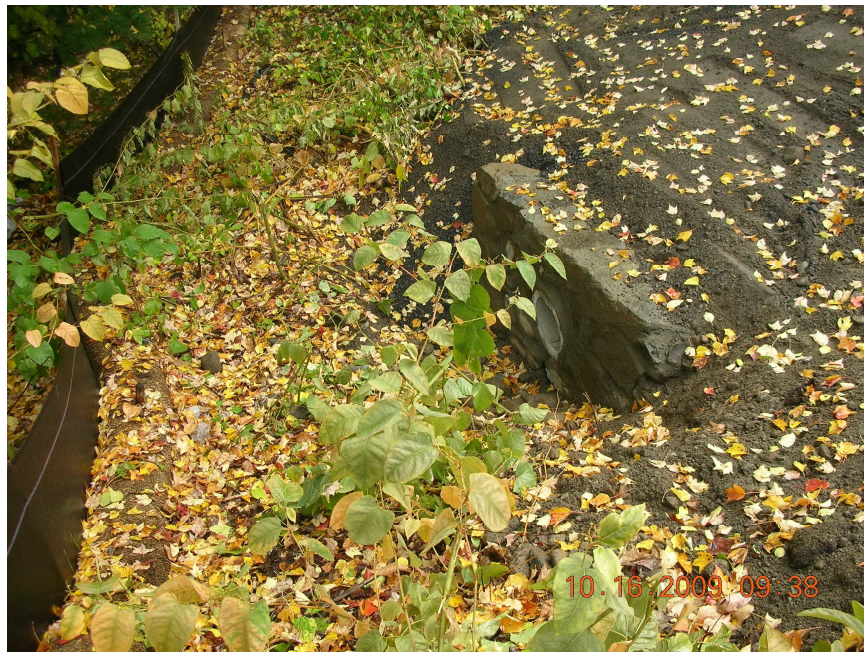
The contractor also installed a new headwall at approximately station point 6+50 on the north side of Route 62. This work was neatly done, and the erosion controls below the work area remain intact. The following photo shows this project:
